Manhole Inspection Summary

Manhole # S13W__002MH

Inspection ☐ Is Incomplete Rating: **3) Fair**

Location Address: **Wilso Dr.**

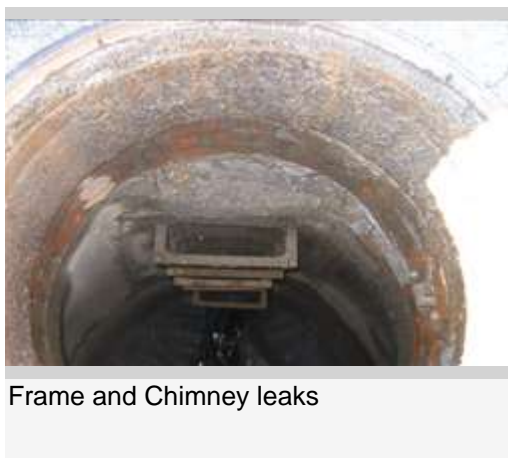
Defect 4

Condition: ☐ Sound ☐ Cracked ☒ **Leaks**

Frame and Chimney leaks

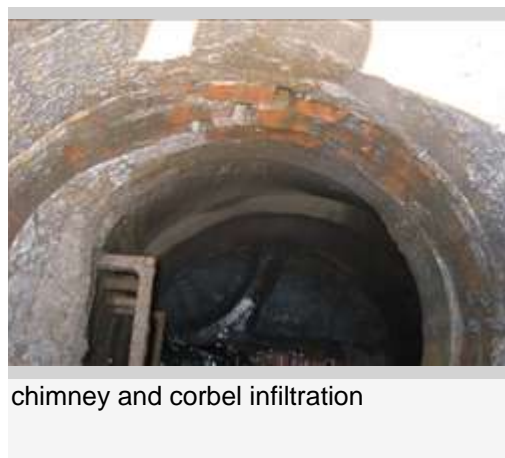
Defect 3

Infiltration: ☐ None ☐ Joint ☐ Cracks ☒ **Mortar** ☐ Roots ☐ Wall

Infiltration: ☐ None ☐ Joint ☐ Cracks ☐ Mortar ☐ Roots ☒ **Wall**

chimney and corbel infiltration

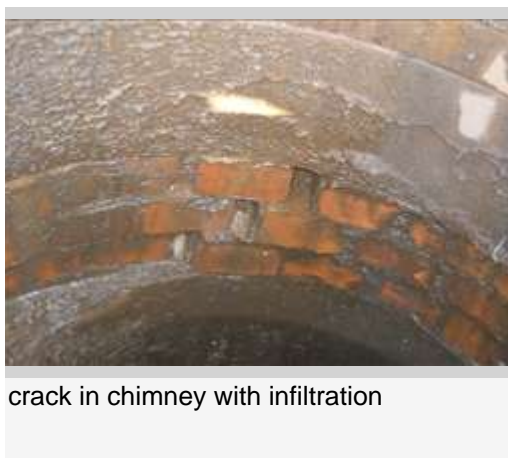
Defect 2

Condition: ☐ Sound ☒ **Cracked** ☐ Root Intrusion ☐ Loose Brick ☐ Deteriorated

crack in chimney with infiltration

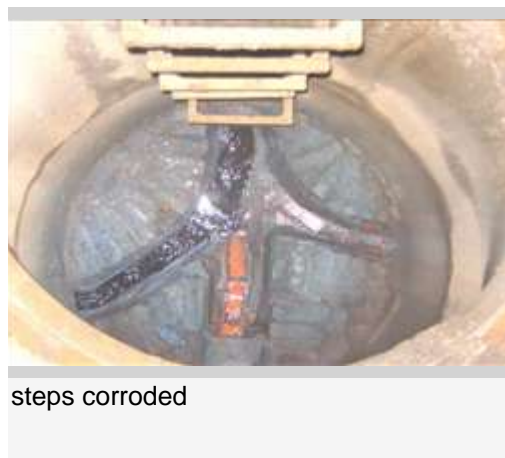
Defect 5

Count: **5** Missing: **0** ☒ **Corroded**

steps corroded

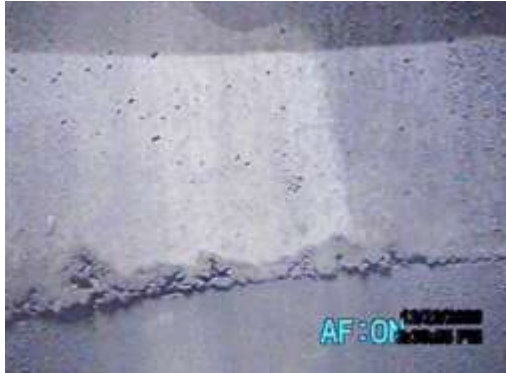
Defect 1

Infiltration: ☐ None ☐ Joint ☐ Cracks ☐ Mortar ☐ Roots ☒ **Wall**

barrel infiltration

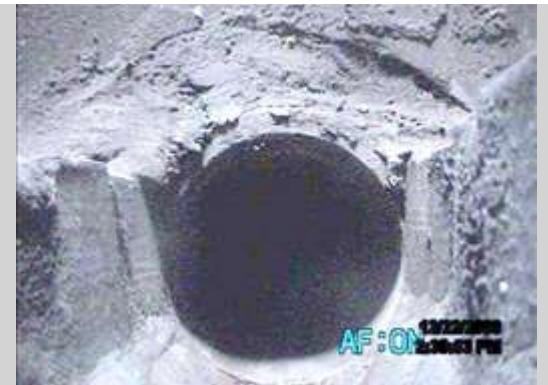
3 O'Clock Inflow

Pipe Height: **6** (in.) Rod and Bar (Angled)
Pipe Material: **Clay** ☐ Pipe Lined
Invert Depth: **8.31** (ft.) Flow Characteristics: **Slow**
Deposits: ☒ None ☐ Mud ☐ Sludge ☐ Debris ☐ Grease
Silt Depth: **0** (in.) Deposits Extent:
Infiltration: **Evidence** Pipe Seal Cond: **Unknown**

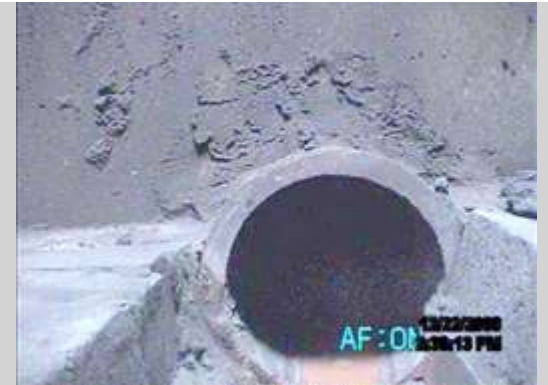
6 O'Clock Inflow

Infiltration: **Evidence** Pipe Seal Cond: **Unknown**

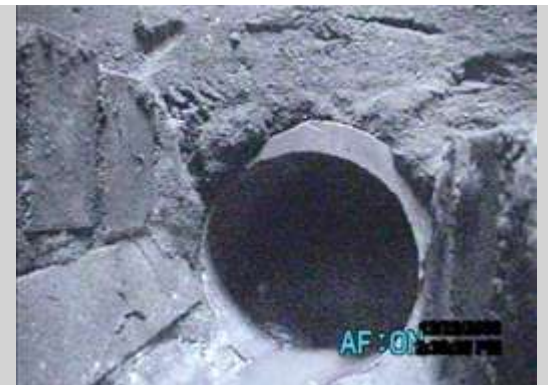
7 O'Clock Inflow

Infiltration: **Evidence** Pipe Seal Cond: **Unknown**
